## Outdoor Type Refrigeration Unit (Non-fluorocarbon Refrigeration Unit with CO<sub>2</sub> Refrigerant) Engineering Service Manual

Model No. OCU-CR200VF5 / OCU-CR200VF5SL

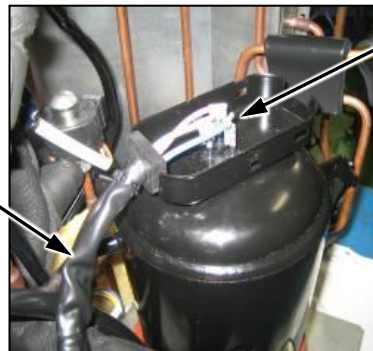
Remove all lead wires of R, S, and T phase from the compressor.

Compressor lead wire harness

R, S, and T phase terminals

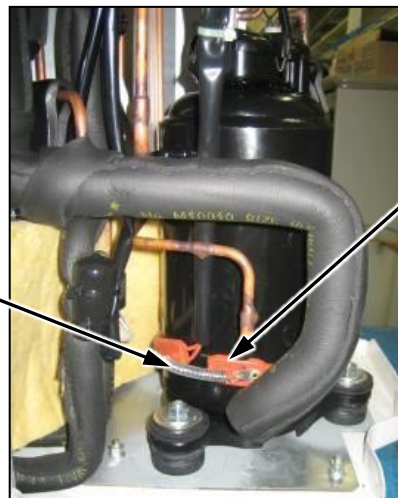
3. Remove the crankcase heater from the compressor.

Crankcase heater  
securing spring

Crankcase heater

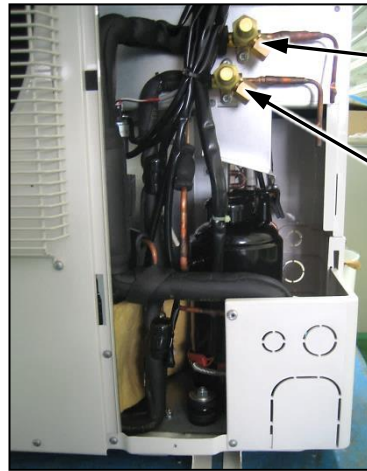
Low pressure service valve

High pressure service valve

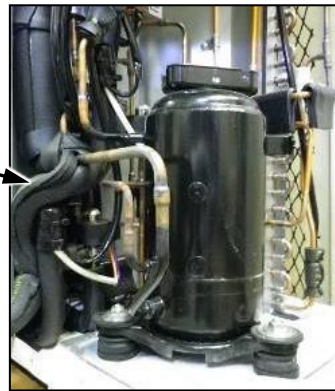
1) In order to avoid any damage from the heat by pipe brazing later, peel off the heat insulation material on the suction pipe to the position shown in the following photo.

Heat insulation material

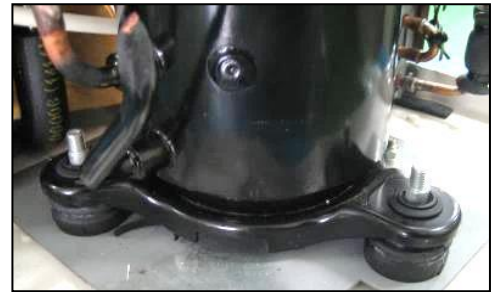
- 1) Remove the securing nut, flat washer, and protection rubber washer in three places (two places in the front and one in the back) of the compressor to be replaced.

Condition after removing nuts, flat washers, and protection rubber washers

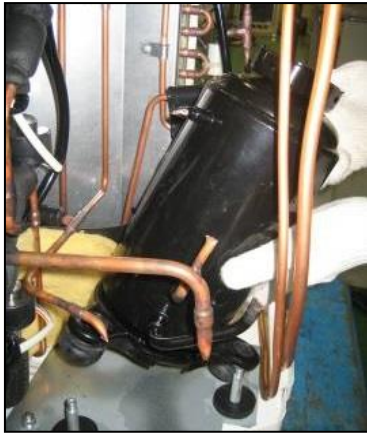
- 2) Remove the compressor from the refrigeration unit.

**Note:** Remove the compressor from the right-hand side while using caution not to apply stress to other piping in the refrigeration unit.

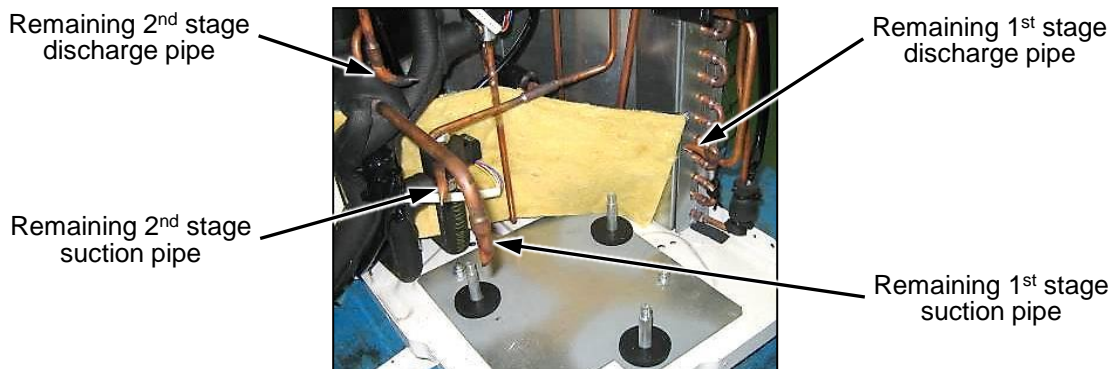
## 7. Removing the cut end pipe

Remove the compressor pipe left on the refrigeration unit side by heating the cut end. Four places in total (1<sup>st</sup> stage suction, 1<sup>st</sup> stage discharge, 2<sup>nd</sup> stage suction, 2<sup>nd</sup> stage discharge).

**Note: 1.** During this operation, always supply nitrogen gas by using the access port of the service valve.

**2.** In order to avoid radiation of the brazing flame, protect rubber, wiring, heat insulation material, sheet metal, etc., by covering them with wet cloths.

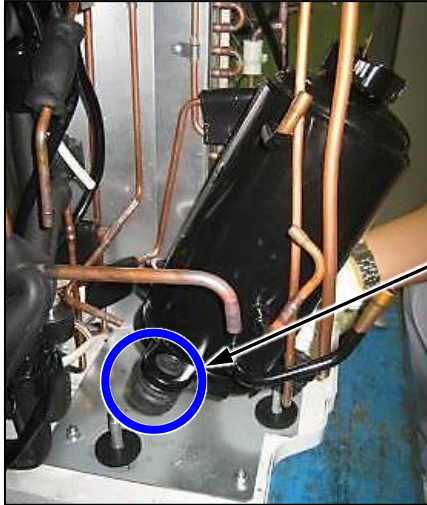
Remove the cushion rubbers (rubber mounts) from the compressor you just removed in step "6. Compressor removal", attach them to the new compressor, and then place the new compressor in its original position.

Condition with an attached cushion rubber (rubber mount)

**Note:** Place the new compressor without causing stress to the refrigerant piping in the refrigerating unit.

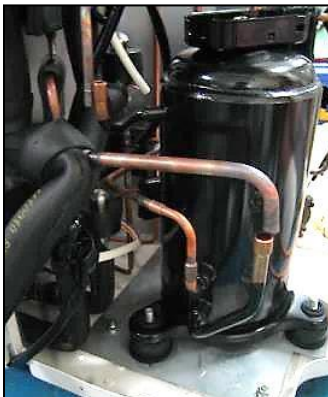
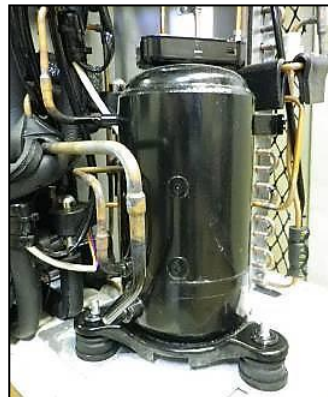
Completed condition after brazing

**Note:** When the screw-fastening is omitted, excessive vibration may cause a failure by piping breakage. For that reason, be sure to fasten the screw.
