## [1] Before performing failure diagnosis

**[3] Troubleshooting and solutions depending on the equipment****1. How to determine the cause and resolve trouble based on the detected error display of the AE-200/AE-50/EW-50**

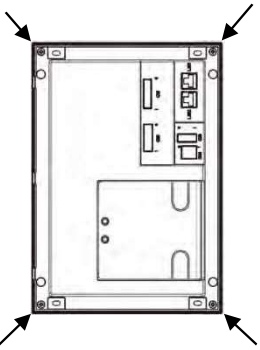
Error code	Description and method of detection	Cause	Check procedure and remedy
		<p>When AE-200/AE-50</p> <p>Remove the four screws in the positions indicated in the figure below, and remove the back cover.</p>

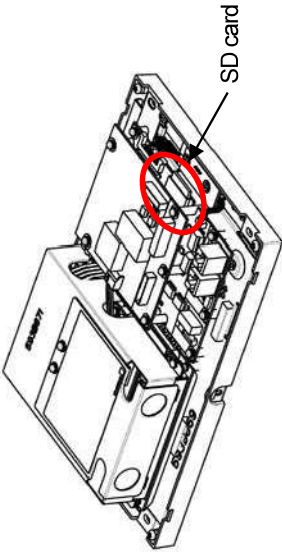
<p>When you remove the back cover, you will be able to see the SD card.</p>

<p><b>Note:</b> When attaching the back cover to the AE-200/AE-50 unit, be sure to follow the procedure below.</p> <ol style="list-style-type: none"> <li>1. Check that the SD card is inserted properly.</li> <li>2. Place the back cover on the unit cover so that the right edge (SD card side) of the back cover is aligned.</li> <li>3. Move the placed back cover to the left so that it fits to the AE-200/AE-50 unit.</li> <li>4. Press the top of the back cover to insert the back cover below the claws at the top of the AE-200/AE-50 unit.</li> <li>5. Tighten the screws in four places on the back cover.</li> </ol> <p>* When attaching the cover, be very careful not to trap a wire or the SD card.</p>

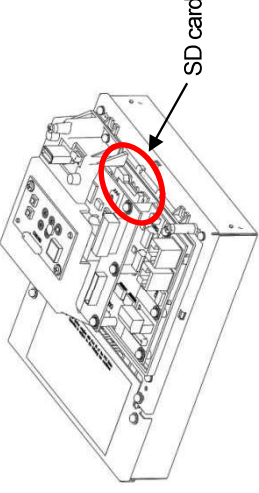
<p>When EW-50</p> <p>Remove the four screws in the positions indicated in the figure below, and remove the back cover.</p>

<p>When you remove the back cover, you will be able to see the SD card.</p>

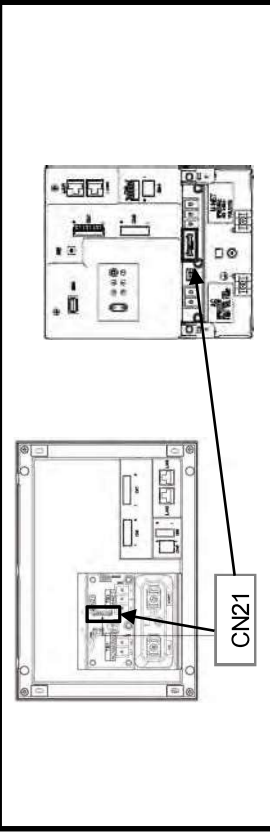
<p>Communication error - Polarity unsettled</p> <p>1. Error detected when the transmission processor which is an M-NET communication component cannot verify the + and - voltage polarity of the M-NET transmission line.</p>	<p>1) There is no voltage between the M-NET transmission line connected to the AE-200/AE-50/EW-50.</p> <p>2) The M-NET transmission line connected to the AE-200/AE-50/EW-50 is shorted.</p> <p>3) The M-NET power supply is duplex feeding and has a different polarity connection.</p>	<p>Causes 1) and 2)</p> <p>Check whether there is a voltage to the M-NET transmission line of the AE-200/AE-50/EW-50 and fix any wiring work mistakes.</p> <p>In the case of a system for which power is supplied from the AE-200/AE-50/EW-50 to the MN converter, check that the M-NET power jumper (CN21) is connected.</p> <div style="text-align: center;">
