## **Technical Bulletin**

Number	P013
Subject	Recommissioning Sanyo/Panasonic ECO-I Systems
	following compressor change
Date	15 October 2015

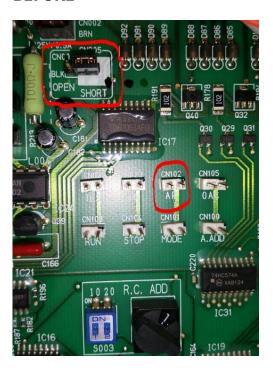
## **BEFORE**

In order to open all the valves to ease the recovery of refrigerant, pressure test and vacuum the "AP" pins on the Outdoor PCB need to be shorted out prior to power being applied.

- 1) Power down
- 2) Remove **OPEN/SHORT** bridge connection from **OPEN/SHORT** position on PCB
- 3) Apply OPEN/SHORT bridge connection to AP Pins
- 4) Power up
- 5) This will enable all Condensing Unit and Indoor Unit valves to be fully open.
